STIHL

Deep Learning Cuts Through Cost, Time and Human Error

From Human Eyes to Machine Vision

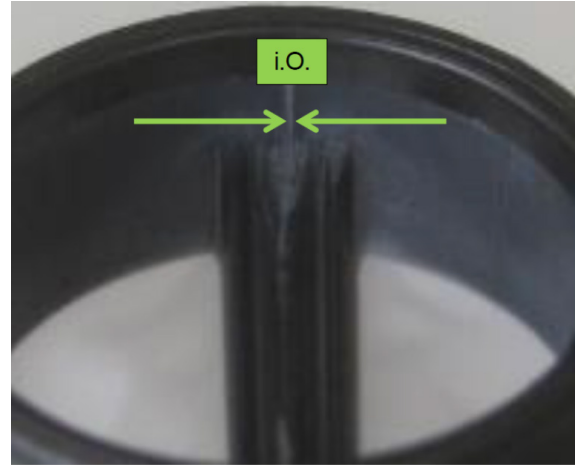
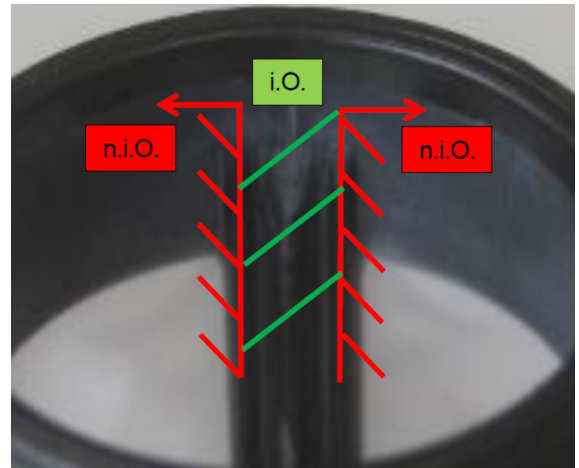
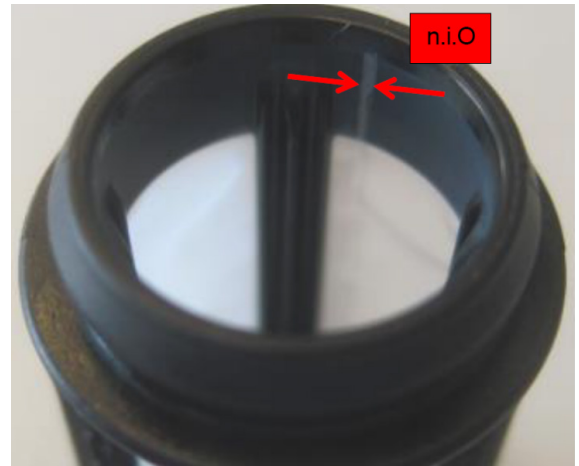
Fromm describes the collection of images as representing “a plastic part with fabric seam, photographed from the inside. In the images, only the footbridge itself contains important information, everything else is irrelevant. To prepare the dataset, therefore, each footbridge is extricated from the general image and sorted into folders classed as ‘good (IO)’ and ‘not good (NIO)’. The team at STIHL undertook the process of manually labeling 2,000 representative parts, each with four images, for a total dataset of 8,000 images. Without guidance, this level of intricacy would have been exceptionally challenging.”

The collection of 8,000 images was provided to the vision experts, who employed [Aurora Imaging CoPilot's](#) interactive environment to train the CNN and produce a classification context file, which was subsequently returned to STIHL for importing into Aurora Design Assistant software environment and used to automatically classify new images into these pre-determined classes. Aurora Imaging CoPilot gives access to pre-defined CNN architectures and provides a user-friendly experience for building the image dataset necessary for training.
